# ARBORICULTURAL ASSESSMENT REPORT

| Site: | 30 Queens Drive, Ashburton, Canterbury |
| Scope: | Undertake a visual tree assessment (VTA) and climbing inspection of the Silver lime <i>Tilia tomentosa</i> growing in the rear of the property. |
| Date: | 31 October 2014 |

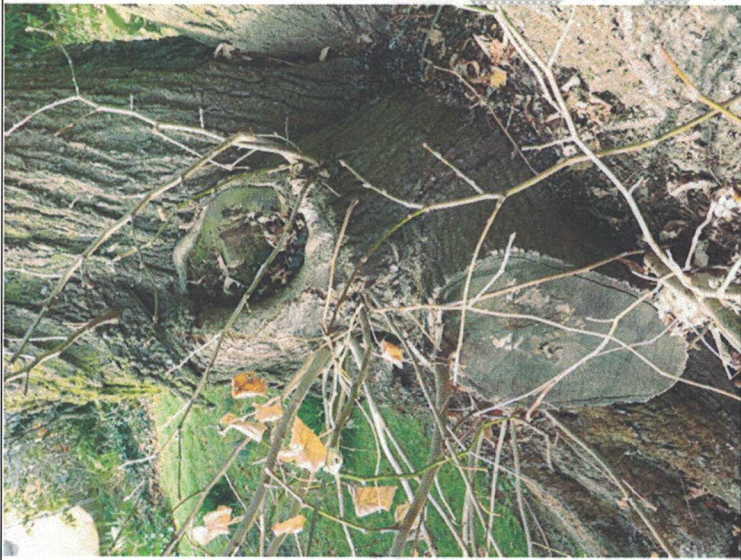
- 5.3 The structure of the tree consists of three main stems emanate from the base of the tree. Stem #1 leans to the south-east and is closest to Mr Dewitt's house. Stem #2 orientates to the west and stem #3 orientates to the north-east. Two large pruning wounds were evident at the stem base, to the north-west, indicating historic stem removal.<sup>2</sup> These wounds were much smaller in diameter than the existing three stems. Included bark was noted at the attachment points of the three stems. Included bark is an internationally recognised and well documented structural weakness in trees.

| Photo 1: previously removed stems | Photo 2: Orientation of the stems | Photo 3: Recently installed Cobra system |

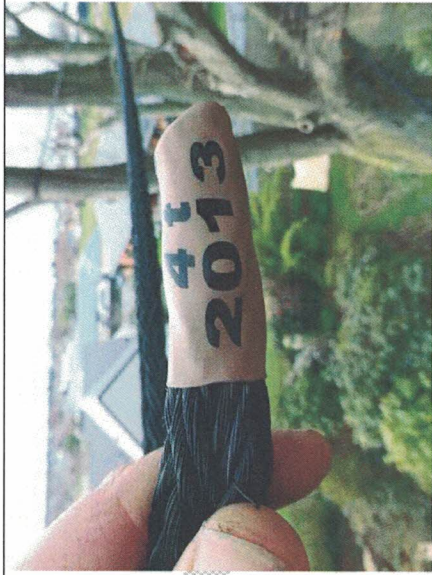
- 5.7 A non-invasive Cobra bracing system has been installed at approximately half the total height of the tree, connecting stems #1 and #2 and #1 and #3. Two Cobra bracing systems were evident, which have been installed at different times. The most recent installation was a 4 ton system in 2013 confirmed by the date end caps installed.<sup>3</sup> An earlier installation is present which is smaller in diameter than the 2013 system and is indicative of a 2 ton system.<sup>4</sup>

- 6.3 In 2013 a second Cobra bracing system has been installed which is noted as being a 4 ton system confirmed by the date end caps installed.<sup>10</sup> This system has been installed incorrectly with significant slack noted in both braces.<sup>11</sup> This is unlikely to have the desired effect of supporting the stems in the event of failure due the extent of travel before the slack is taken up.

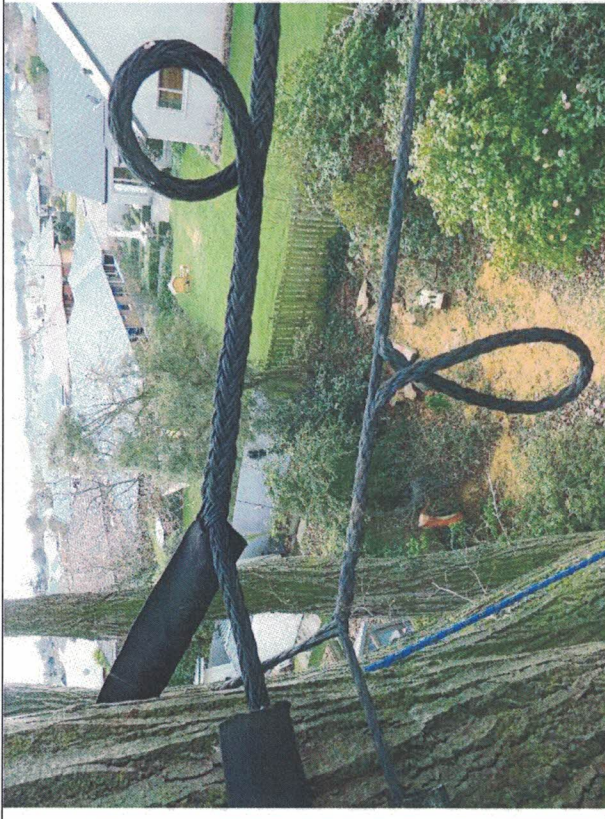
- 5.8 The earlier Cobra system connecting both stem #1 and #2 (east-west) and stem #1 and #3 (north-east – south-west) was noted as being at high tension. The system has been installed at natural forks in the branch structure. Incremental growth of the trees stems has partially included the points of attachment.<sup>5</sup> There is evidence of previous failure of a cobra brace between stem #1 and #2 with the remnants of the brace trees partially included.<sup>6</sup>

- 6.2 The installation of the Cobra system will have been an attempt to prevent the potential failure of the stems, the braces were noted as being under high tension. Mr Walter Fielding – Cotterell's report dated 21 January 2014 states that the system was installed in 1997. As stated in paragraph 5.7 above, the diameter of the previously installed system is indicative of a 2 ton system which I consider to be inadequate for the size of the stems of the tree which are likely to be in excess of 4 ton.

- 6.4 Due to the tension noted on the pre-existing braces, failure of these braces is considered likely. Mr Walter Fielding – Cotterell's report dated 21 January 2014 notes that when the recent Cobra system was installed in December 2013 one of the braces was found to be broken, this is likely to have been the brace between stems stem #1 and #2 (east-west) as noted in paragraph 5.8.

Photo 4: Recently installed 4 ton system on top. Previously installed in the bottom indicative of a2 ton system. Note this brace is under high tension. Stump of the recently removed Oak visible to the rear boundary.

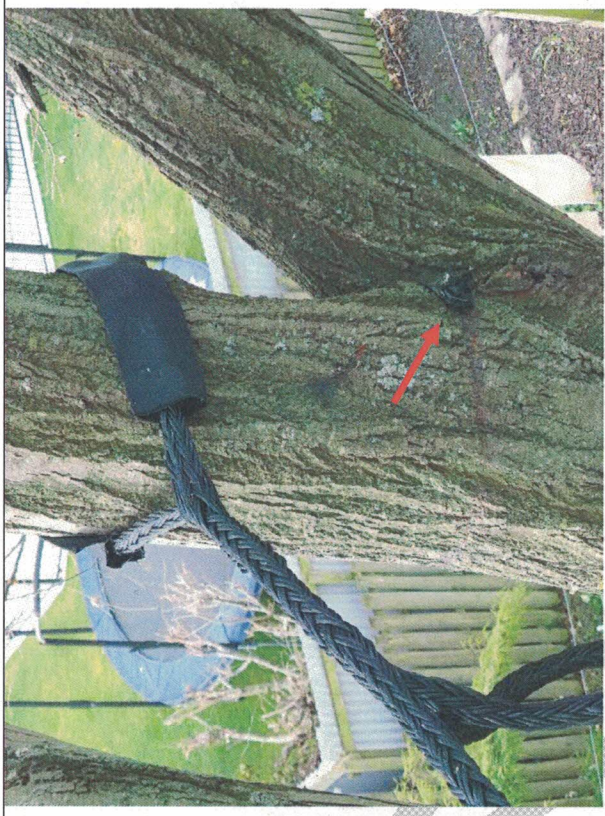
- 5.9 The Cobra system installed in 2013 has been installed above the earlier system. Significant slack was noted in the recently installed braces.
- 5.10 The installed braces connecting stems #1 and #2 are connected to the main stems at an approximate diameter >450mm.<sup>7</sup> The stems have a similar angle of lean and the tension between at the connecting points is likely to be similar.

Photo 5: Previously failed cobra system partially included at the point of attachment.

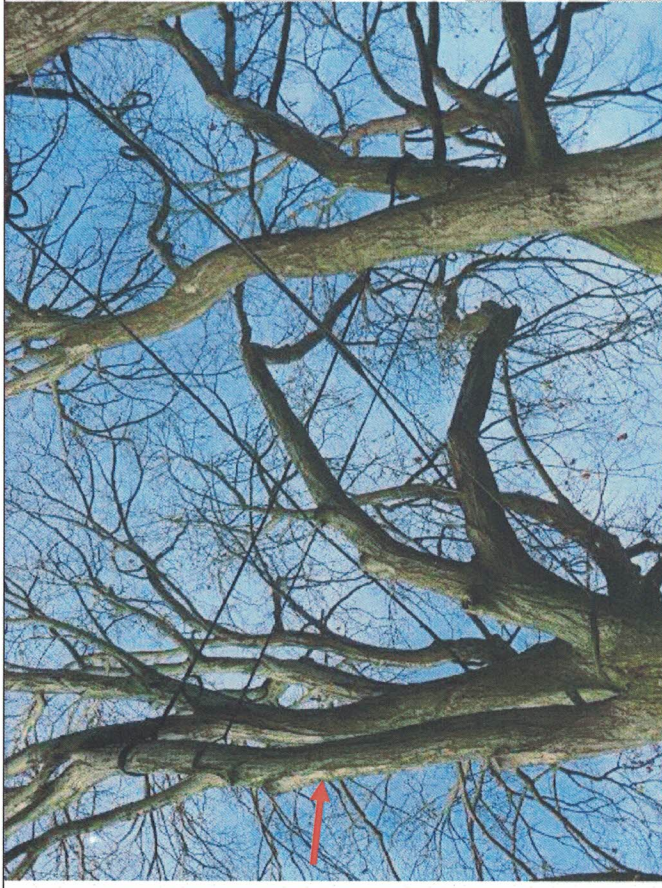
- 5.11 The installed braces connecting stems #1 and #3 are connected via a secondary branch on stem #3 with an approx. diameter of 300mm and the main stem of #1 with an approx. diameter >450mm.<sup>8</sup> Significant end weight was noted on stem #1 which leans towards the property and is at a greater angle than stems #2 and #3. Due to the end weight noted the secondary branch attached of the Cobra system on stem #3 has been pulled into the adjacent secondary branch lateral with an approx. Diameter <200mm at the point of attachment.<sup>9</sup>

Photo 6: The installed braces connecting stems #1 and #3 are connected via a secondary branch on stem #3 with an approx. diameter of 300mm

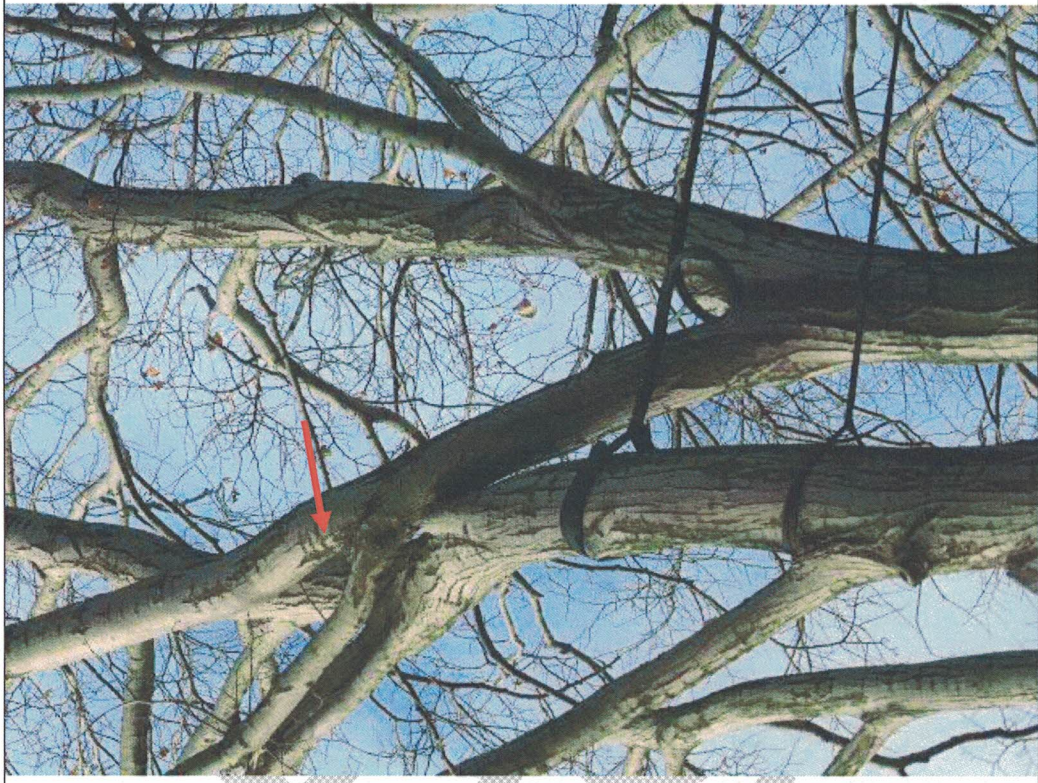
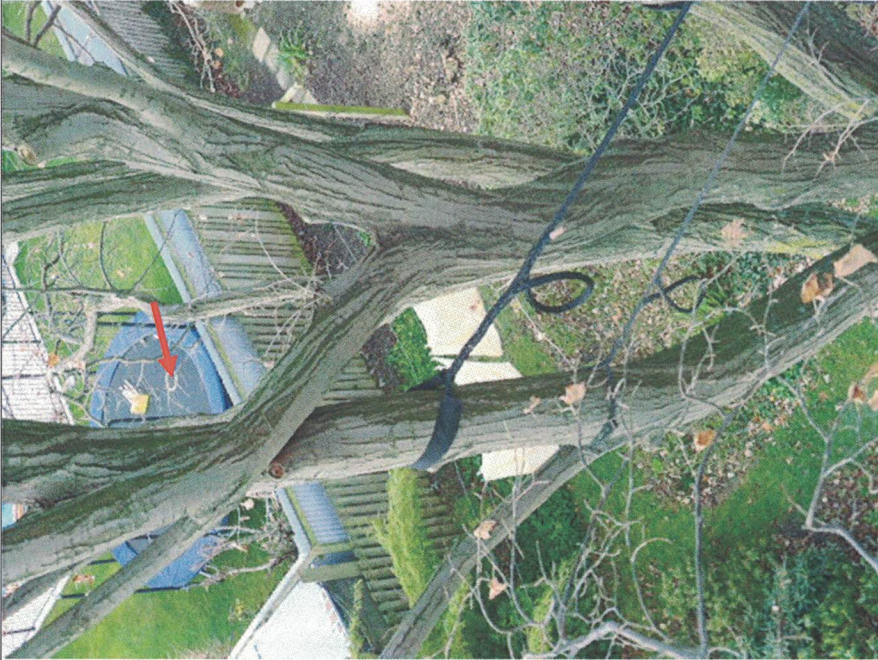
supported by a lateral branch <200mm diameter which is supporting the entire weight of stem #1. With the pre-existing brace (indicative of a 2 ton system) considered to be inadequate and the recently installed brace installed incorrectly with a large amount of slack, there is a high risk of stem failure.

Photo 7: The secondary branch supporting Stem #1 has been pulled into the adjacent secondary branch lateral with an approx. Diameter <200mm

Photo 8: The secondary branch supporting Stem #1 has been pulled into the adjacent secondary branch lateral with an approx. Diameter <200mm

- 7.7 It is my opinion that mitigation pruning is required in the first instance to all three stems to reduce the end weight loading and pressure on the bracing systems and basal stem unions. The tree can then be further evaluated with regard to its future management and protection status.

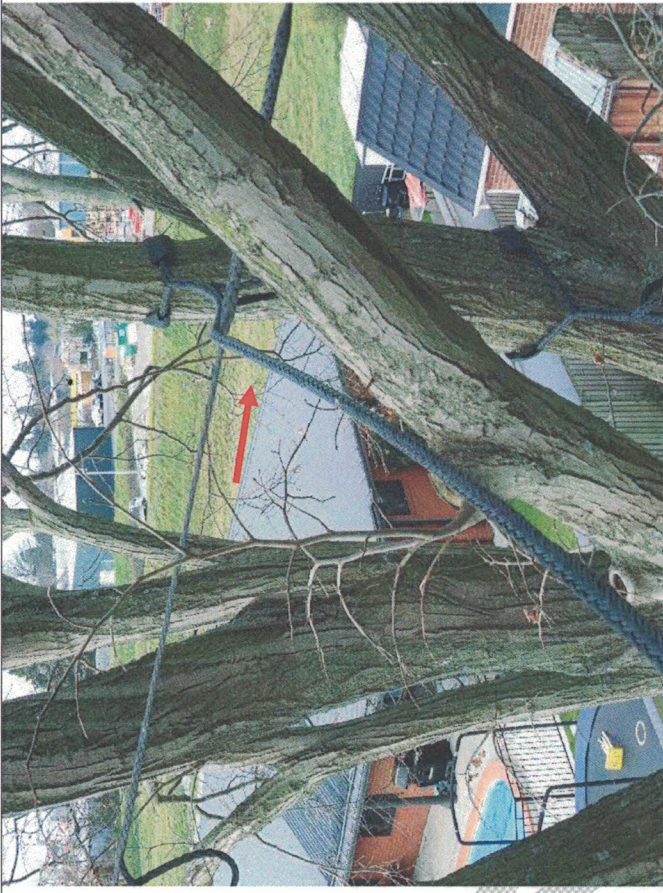
Photo 9: Incorrectly installed 4 Ton Cobra brace with significant slack in the system note.
